1101 East Pike Street  
Seattle Landmark  
Nomination

Prepared by Tom Heuser, Marvin Anderson, and Adam Alsobrook  
(Revised December 3, 2019)

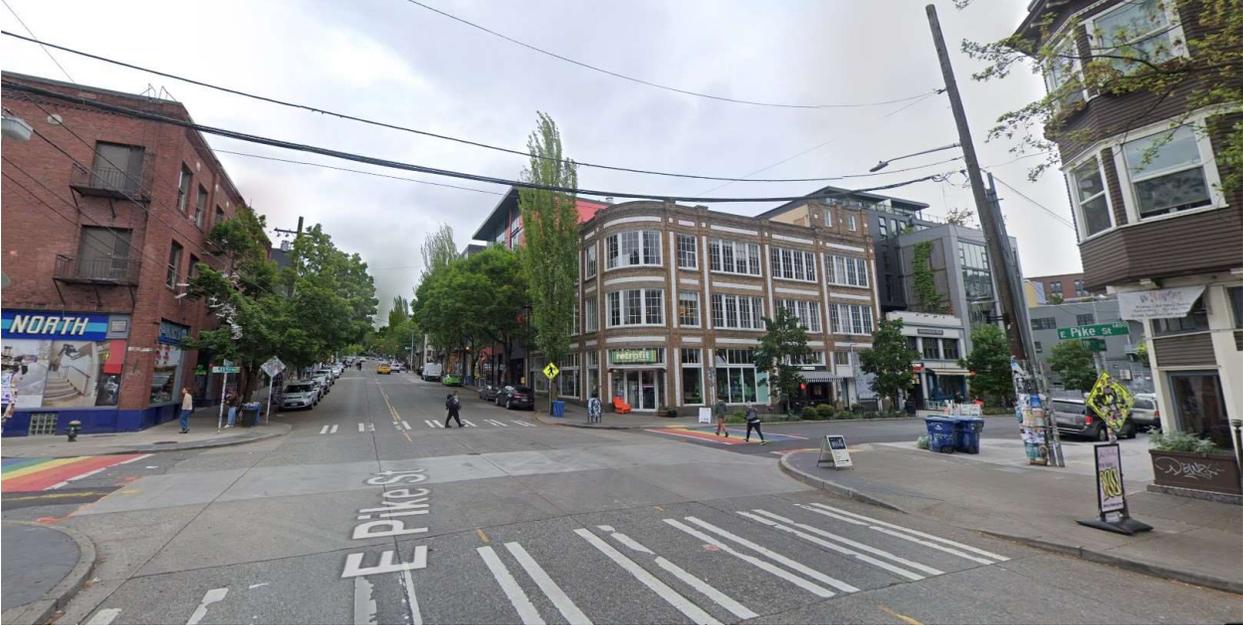
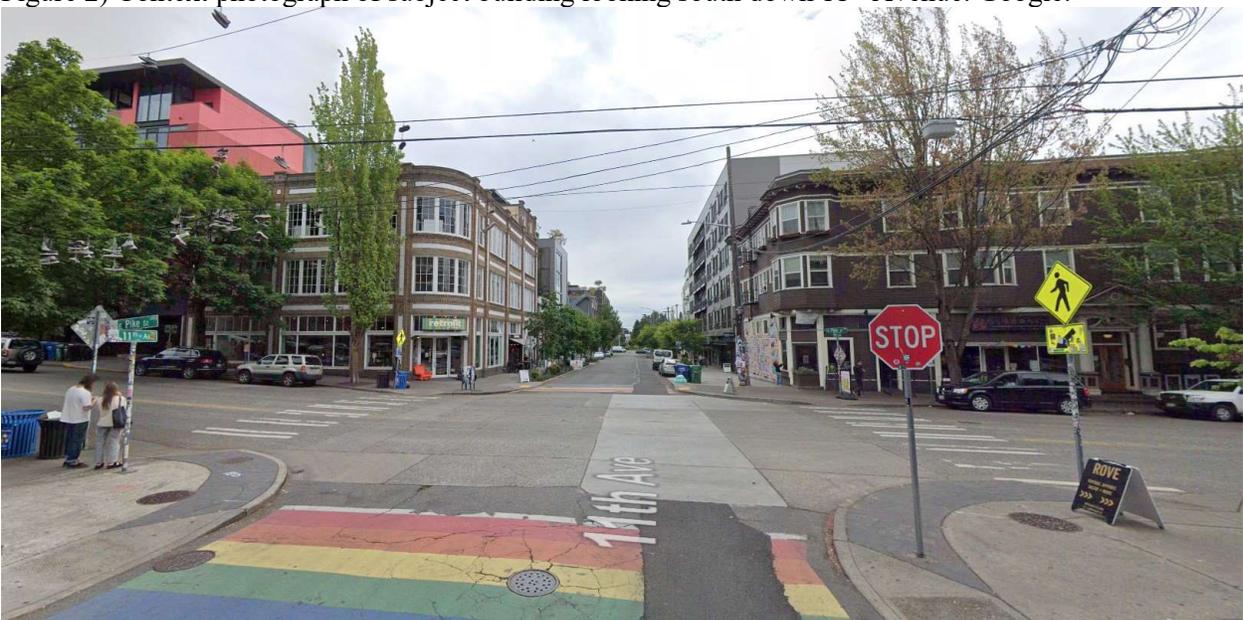
Figure 1) Context photograph of subject building looking east up East Pike Street. Google.

Figure 2) Context photograph of subject building looking south down 11<sup>th</sup> Avenue. Google.

This report provides information about the existing commercial building situated at the southeast corner of 11<sup>th</sup> Avenue and East Pine Street in Seattle. The subject property consists of a rectangular parcel measuring approximately 80 feet by 64 feet and oriented north-south along 11<sup>th</sup> Avenue. The grade along the north façade slopes down approximately 4 feet from east to west, and the east façade party wall is obscured by the recently constructed building to the east. There is an approximately 4 foot wide sidewalk between the southern façade of the building and the adjacent property to the south. This paved area is generally level. The grade along the western façade of the existing building is also generally level. There is not an alley adjacent to the site. (Figures 1 and 2)

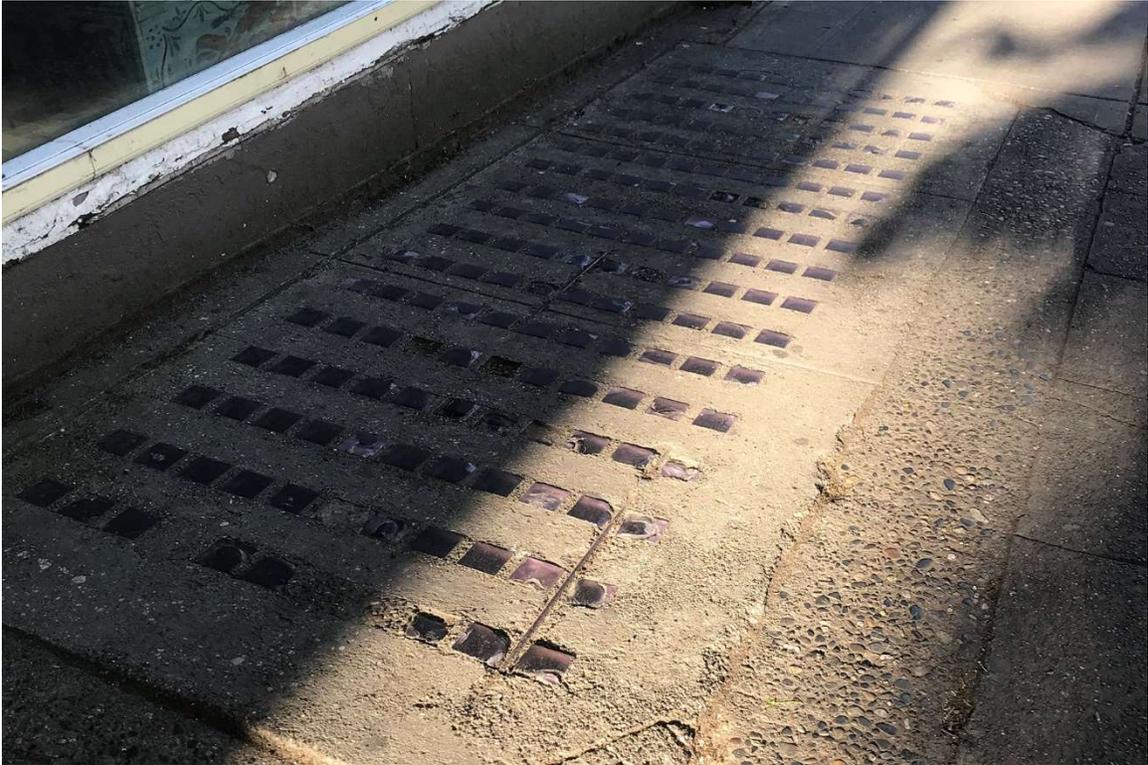
Figure 8) Sidewalk prism lights at areaway.

Concrete paved public sidewalks are located to the north and west of the subject building. The sidewalk on the north side of the building is approximately 10 feet wide. There is a section of glass areaway prisms along the north property line of the building that measures approximately ten feet by 4 feet. The condition of the areaway vault below is unknown. (Figure 8) There are two street trees located in tree wells at the north sidewalk. The easternmost street tree is a privately maintained Norway maple (*Acer platanoides*), and the westernmost street tree is an Armstrong Freeman (Red) maple (*Acer x Freemanii* ‘Armstrong’) maintained by the Seattle Department of Transportation (SDOT).<sup>4</sup>

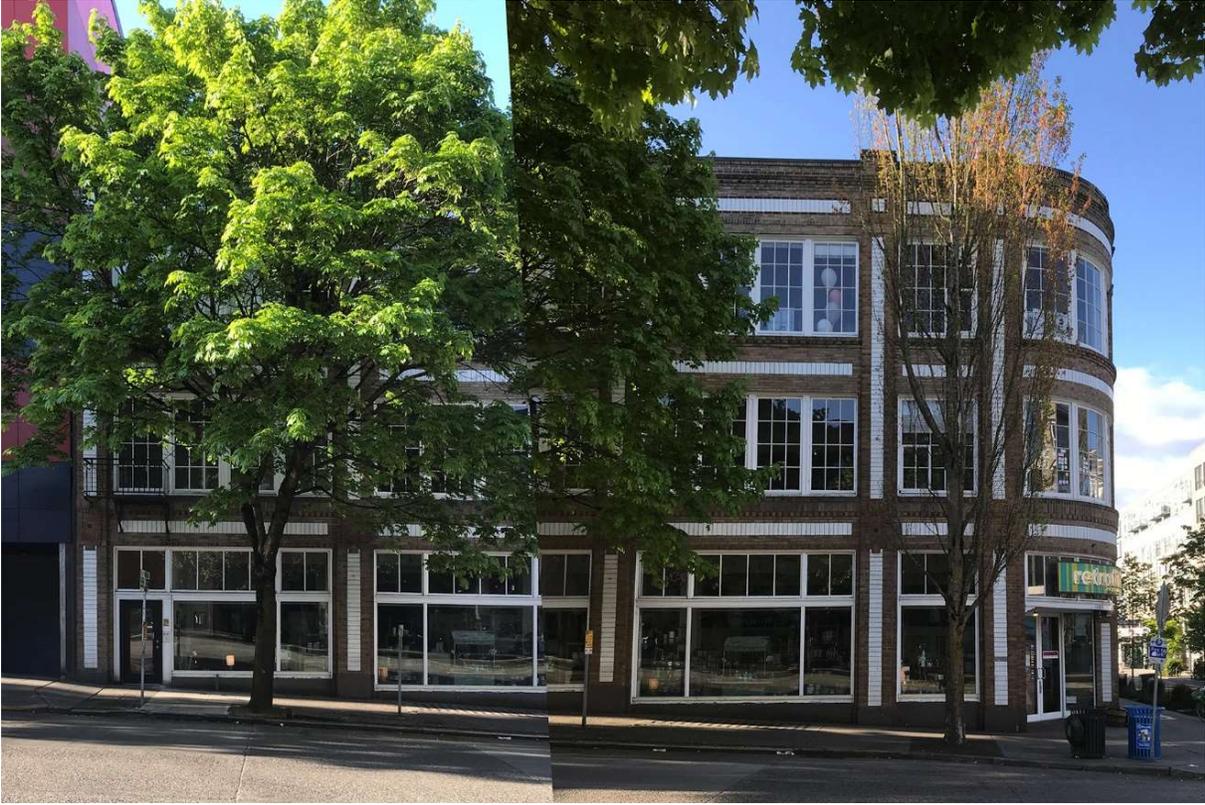
Figure 10) Composite image of north building façade.

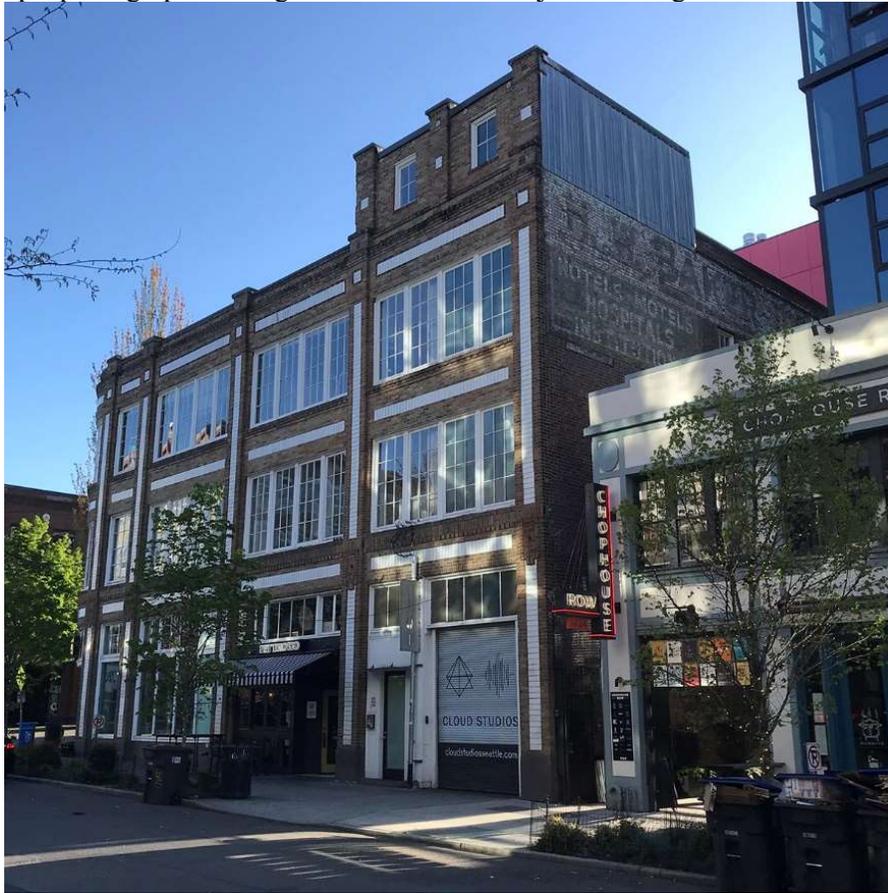
Figure 16) Oblique photograph looking northeast toward subject building.

Since the hoistway for the former car elevator is located at the southwest corner of the building, the westernmost bay of the south façade does not have any window or door openings. The brick masonry at the south wall of the penthouse at the roof level collapsed and fell off the building during the 2001 Nisqually earthquake. This area of missing masonry is currently covered with vertical seam galvanized metal siding. (Figure 16)

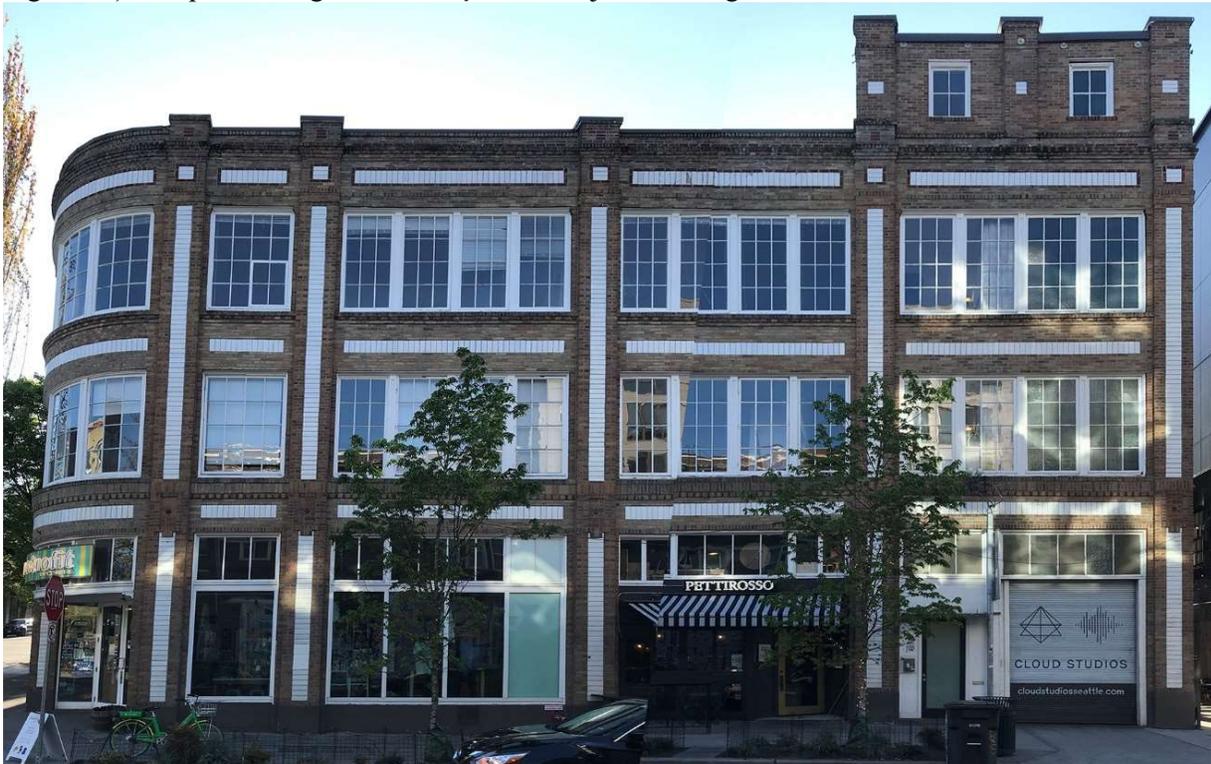
Figure 17) Composite image of west façade of subject building.

Like the primary corner entrance pavilion and north façade of the building, the west façade of the subject building is a primary façade and is clad with loadbearing rug face brick masonry laid in a regular, running-bond pattern, with additional brick details laid in header, rowlock, or soldier courses. (Figure 17) There are five brick masonry pilasters on the west façade, and each of these pilasters feature the rectangular white glazed ceramic tile noted above in the description of the north facade. The northernmost bay of the west façade measures approximately six feet between the pilasters, and the remaining three bays to the south each measure approximately sixteen feet between the pilasters. The bulkheads at the ground level storefront windows at the northernmost bay and the bay immediately to the south have been altered from their original condition, and are now painted stucco plaster. The storefront windows are plate glass with painted wood frames and transom windows above. The storefront in the next bay to the south has been altered from its original condition, but the painted wood transom windows are still located above the storefront. In the southernmost bay of the building, there is an entrance door with transom window above. Immediately to the south of this entrance door is a large painted metal roll-up door with a transom window above. This door was installed circa 2016 as a replacement for the previous roll-up door, which was also not original to the building. However, the transom window above the roll-up door is original to the building. This large opening in the façade allowed vehicles to access the car elevator located at the southwest interior corner of the building.

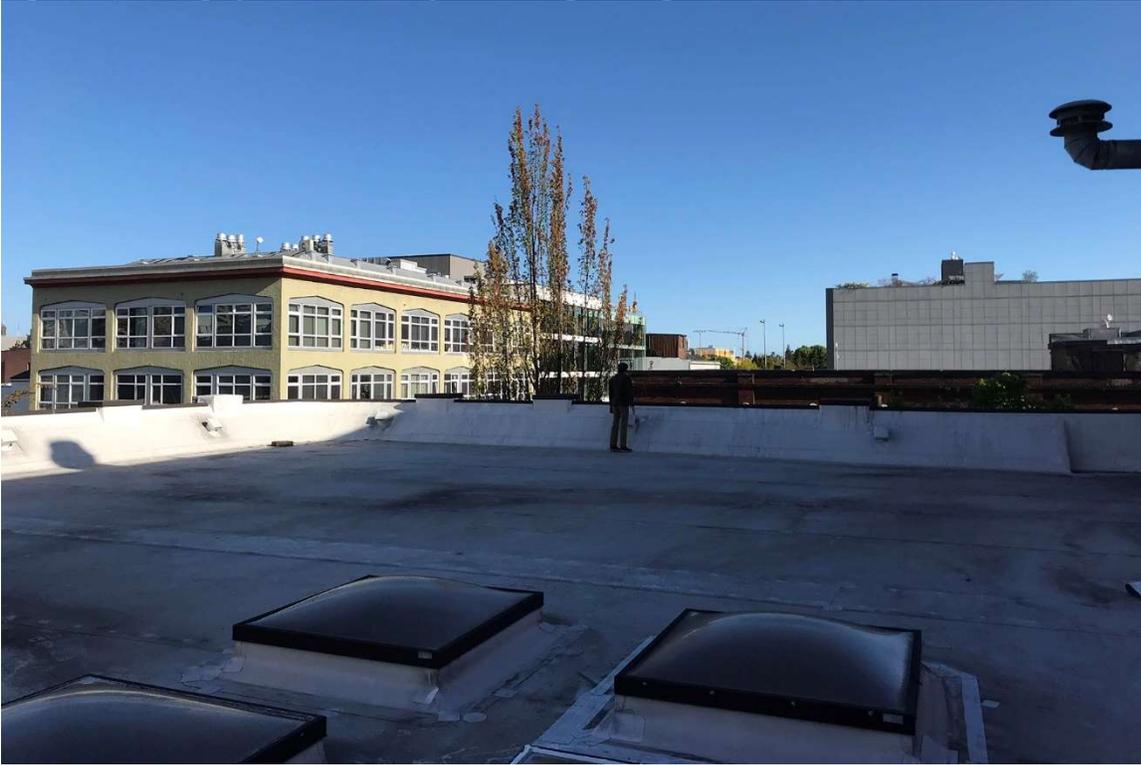
Figure 18) Photograph of roof of subject building looking northwest.

It appears that the roof was replaced in 2008 at the same time when the parapets on the north, west, and south sides of the building were seismically braced. The roof is generally flat and is sloped slightly to drains located at the northeast and southeast corners of the roof surface. The parapets extend above the roof surface by about four feet around the entire perimeter of the roof. The roof is clad with a modern plastic roofing material, such as a vinyl or thermoplastic polyolefin (TPO). (Figure 18) The parapets are capped with dark painted sheet metal flashing. There are four clear acrylic skylights mounted on curbs at roughly the center of the roof area. An air conditioning unit is mounted on wood skids at the east side of the roof next to the original brick masonry chimney. The brick masonry chimney has been wrapped in dark painted sheet metal

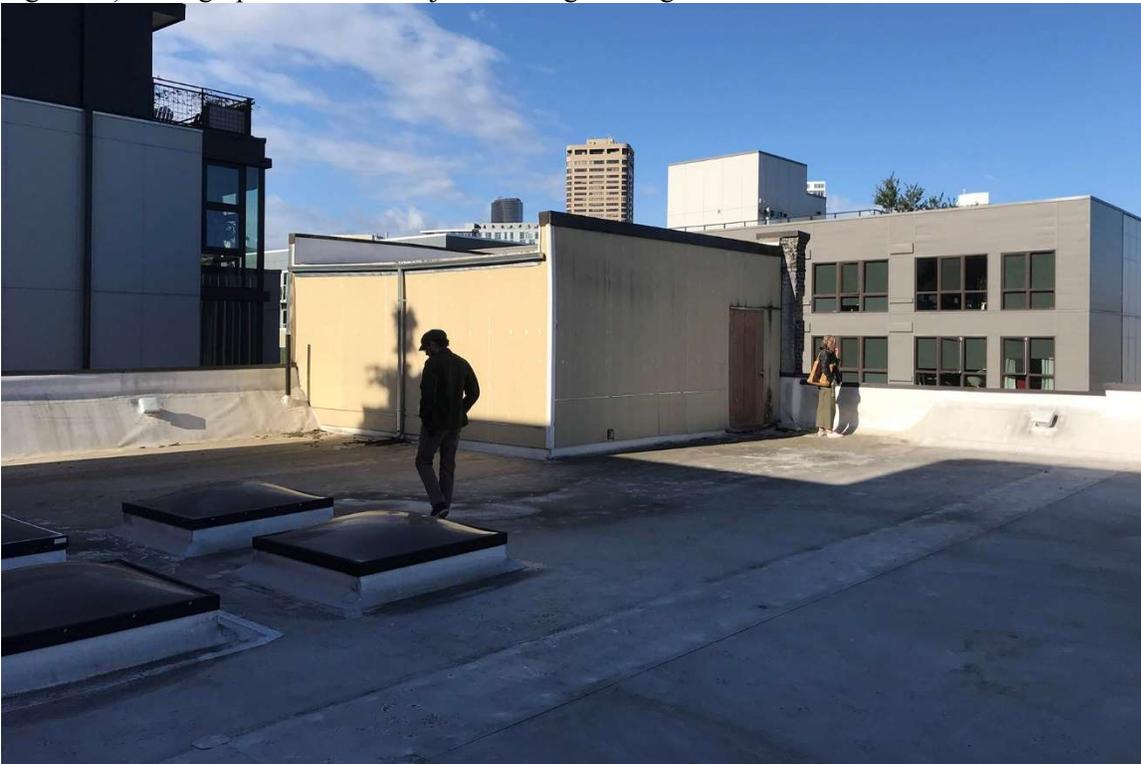
Figure 19) Photograph of roof of subject building looking southwest.

The brick masonry at the east and north walls of the rooftop penthouse appear to have been replaced with painted cement board siding. This work may have occurred after the 2001 Nisqually earthquake. The north, west, and south walls of the penthouse have short parapets that are about two feet high. The roof of the penthouse is clad in the same material as the rest of the main roof surface, and the parapets are capped with the same dark painted sheet metal flashings. A gutter and single downspout at the east wall of the penthouse drains water from the penthouse roof and discharges it onto the roof surface. (Figure 19)

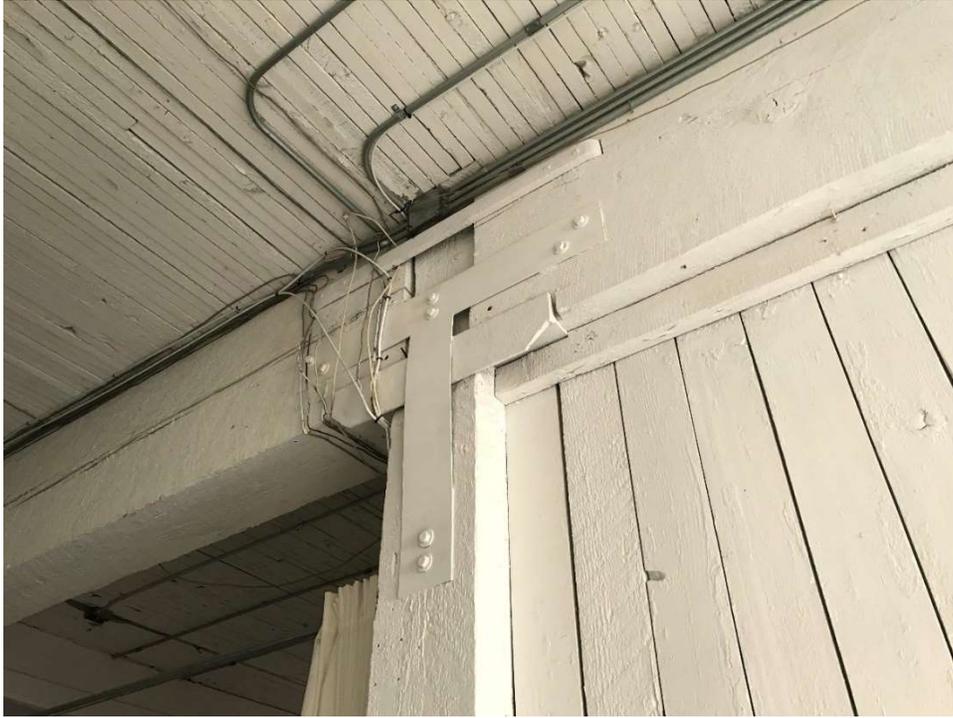
Figure 26) Photograph of heavy timber structural frame at ceiling of second floor level of subject building.

The primary structure of the building is heavy timber mill construction, with a reinforced concrete foundation. The exterior walls of the building are load-bearing brick masonry. The building is three-stories tall over a full basement, with a partial mezzanine level located between the ground floor and second floor levels. A penthouse at the roof level contains the freight elevator overrun space and an exit stairway. The building is listed on the City of Seattle's list of unreinforced masonry (URM) buildings, however, the list notes that a permitted retrofit has been performed on the building.<sup>5</sup>

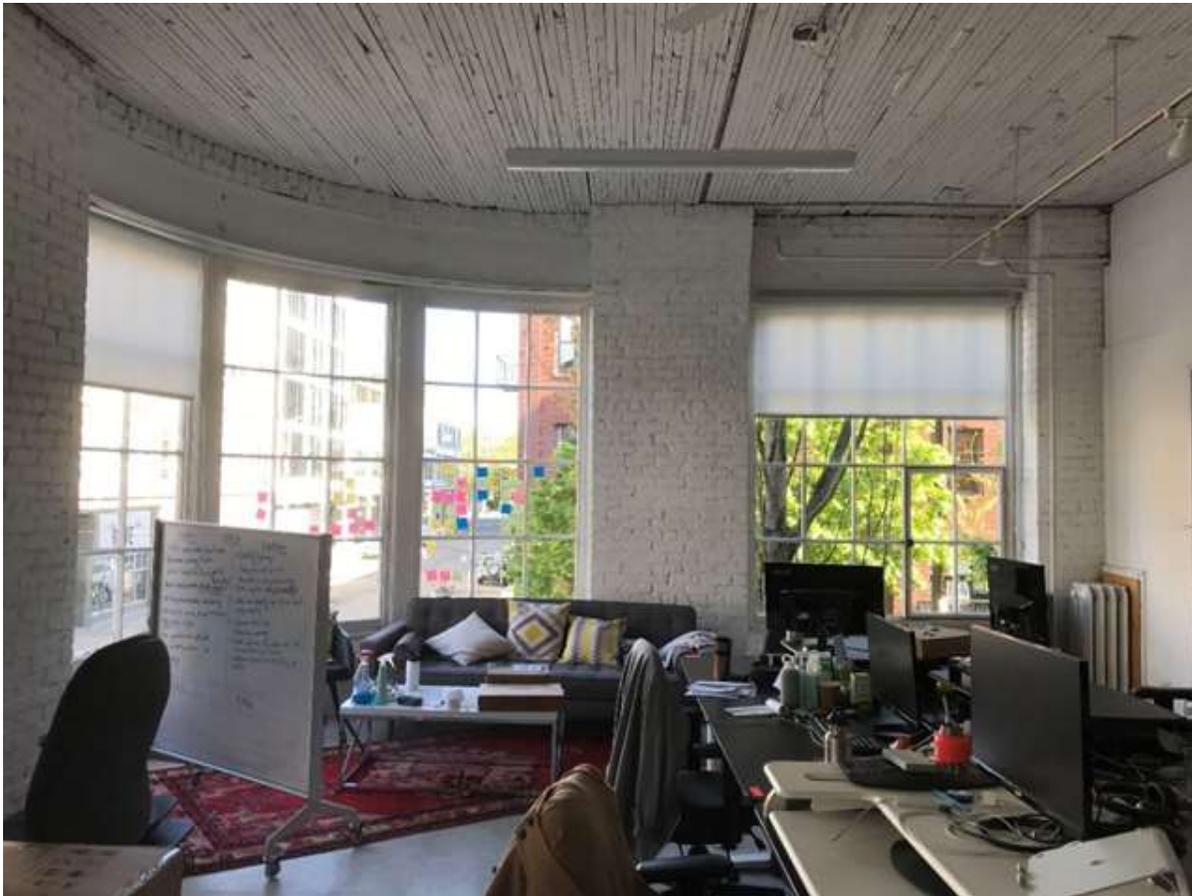
Figure 27) Photograph of curved steel 'I' beam lintels at second floor level of subject building.

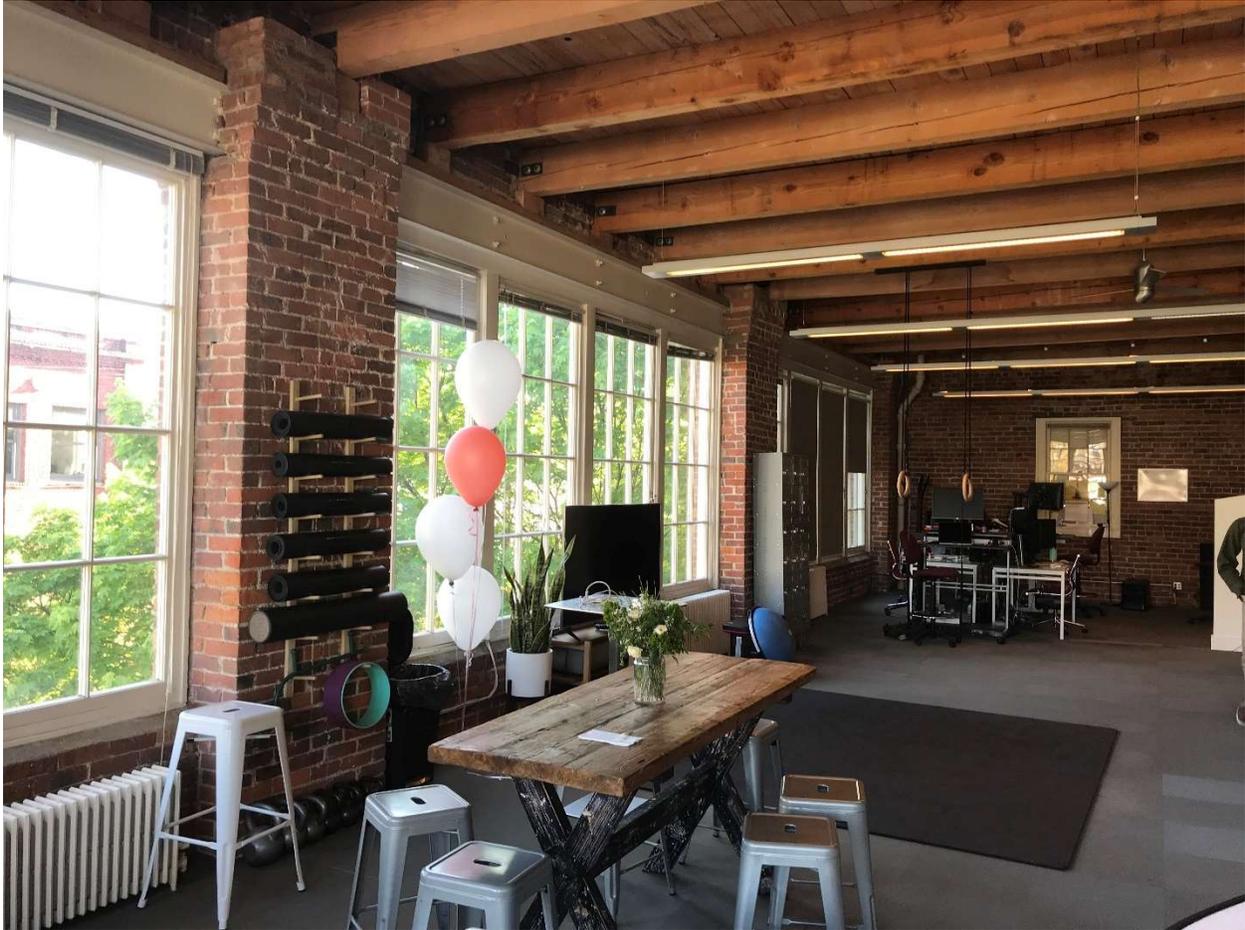
Figure 30) Photograph of exposed brick masonry exterior walls at north end of third floor level open office space.

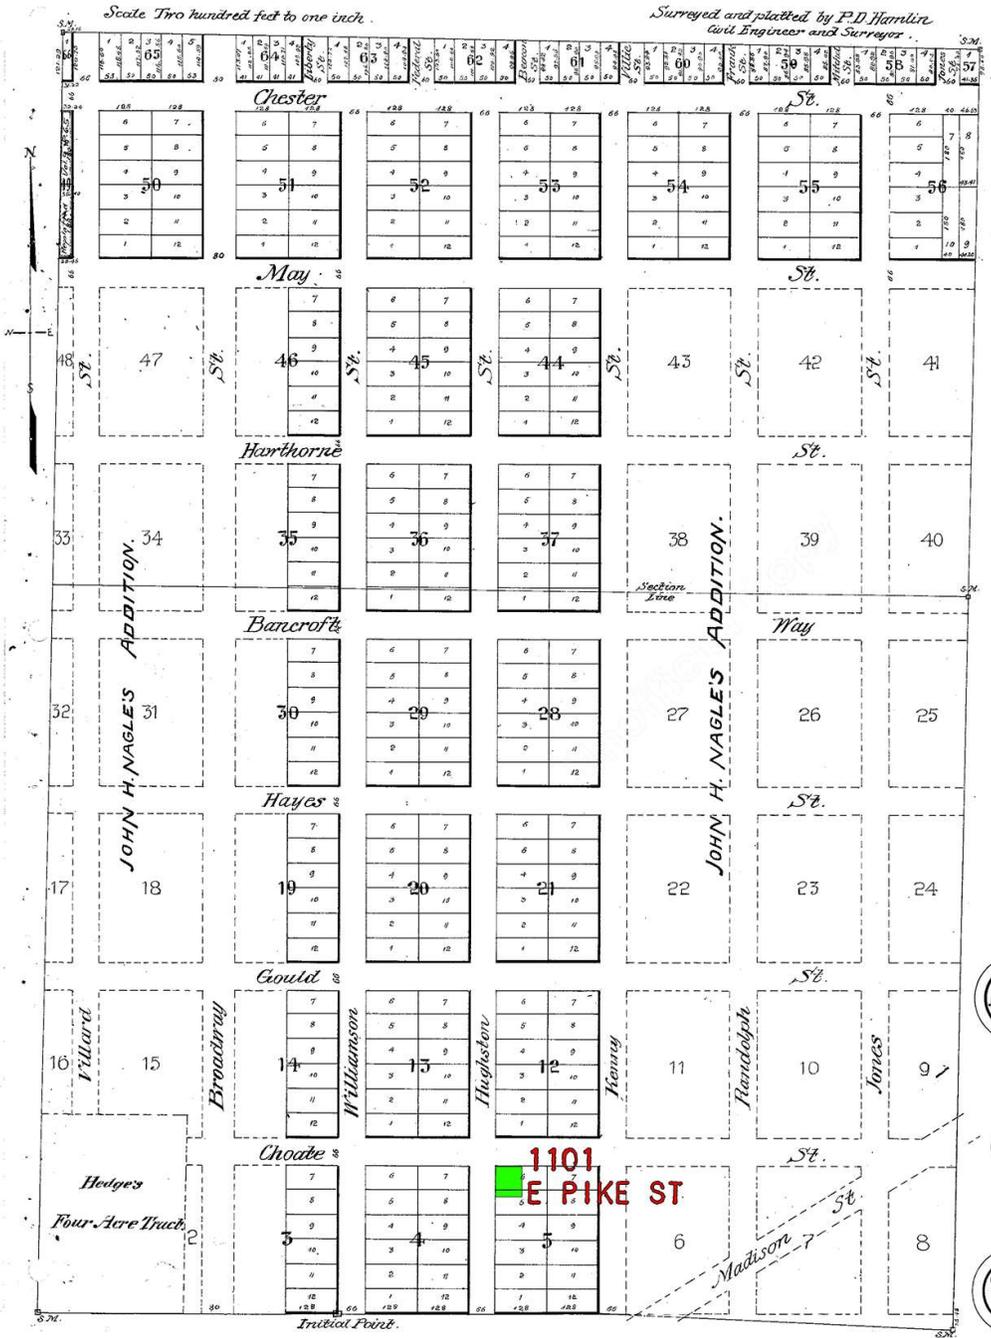
Figure 50) Composite image of surrounding plat maps, various dates 1880-1892. King County Archives. The yellow square inside Nagle's Second Addition marks the location of the subject building.

Figure 50) Composite image of surrounding plat maps, various dates 1880-1892. King County Archives. The yellow square marks the location of the subject building.

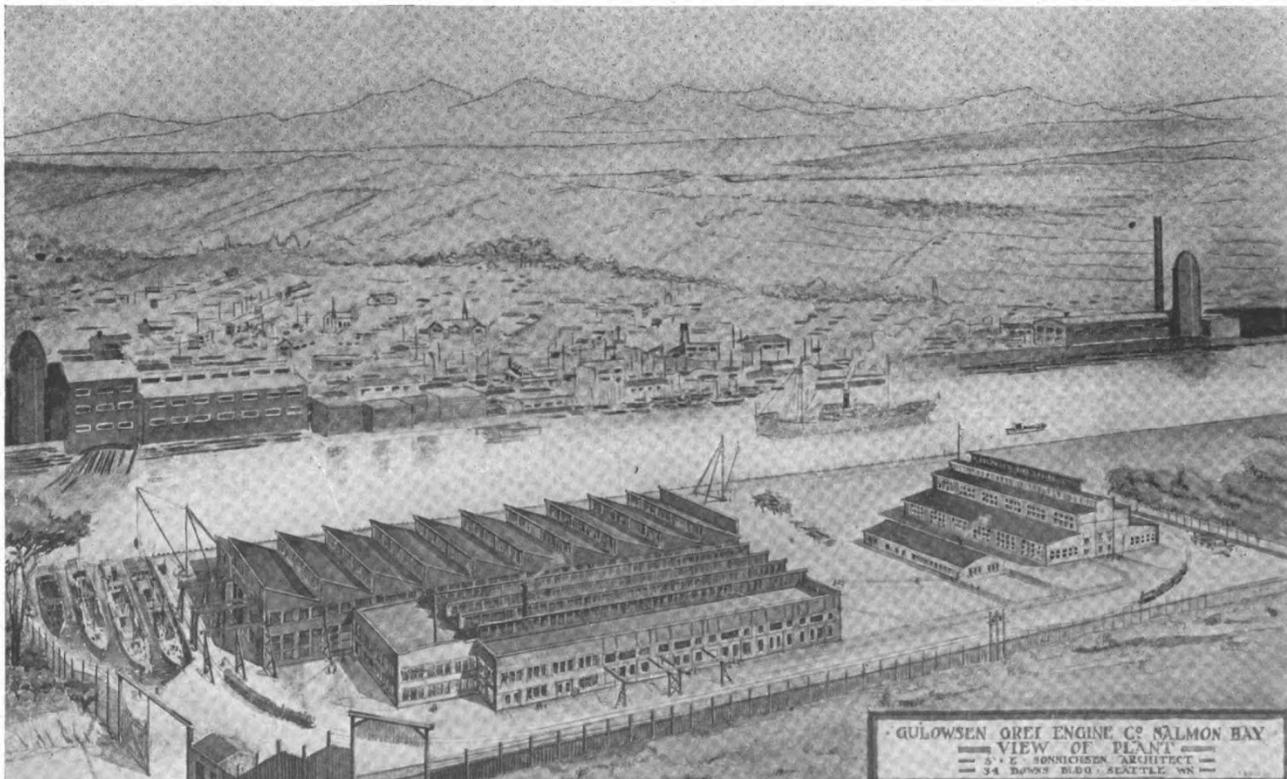
Birds-eye view of the Gulowsen-Grei factory showing its position on Lake Washington canal near Salmon Bay, and the excellent deep-water and railroad facilities.—Note the adjacent fitting-out dock. Salmon Bay is the greatest rendezvous for motor fishing-vessels on the Pacific Coast

Figure 60) Gulowsen-Grei Engine Co., 1918. *Motorship*, April 1919, p. 46
